Complete Vehicle Inspection, Valuation & History Report

## 2018 AUDI S5

VIN: WAUC4CF58JA031138

# Vehicle Damage Assessment

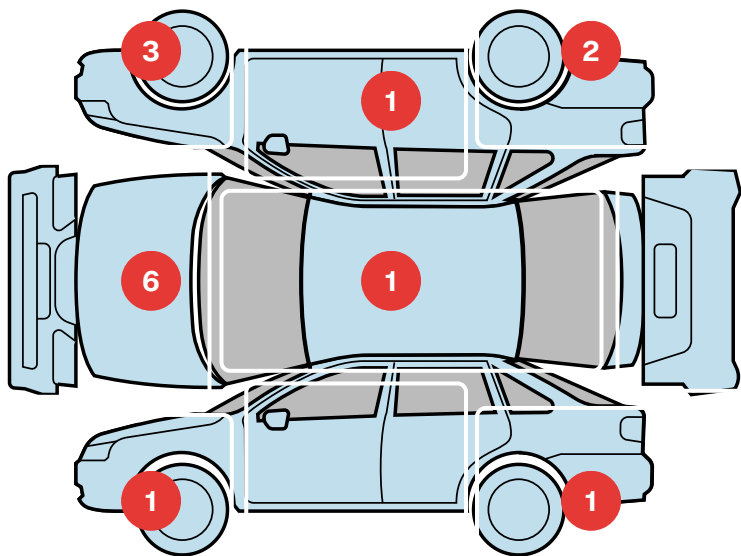
| Reconditioning Cost Summary | | | |
|---|---|---|---|
| B structural pillar (a/b/c/d) | SEV1 - Cosmetic | Compound+polish | 1 x \$69 |
| Center 2nd-row seat (rear/bench) | SEV1 - Cosmetic | Interior cleaning | 1 x \$53 |
| Front bumper | SEV2 - Minor | Panel respray (consolidated) | 1 x \$998 |
| Front hood/bonnet | SEV2 - Minor | Touch-up | 1 x \$115 |
| Front hood/bonnet | SEV2 - Minor | Touch-up | 1 x \$153 |
| Front left aluminium rim/alloy wheel | SEV2 - Minor | Rim refinish | 1 x \$130 |
| Front right aluminium rim/alloy wheel | SEV2 - Minor | Rim refinish | 1 x \$122 |
| Front right aluminium rim/alloy wheel | SEV2 - Minor | Rim refinish | 1 x \$130 |
| Front right door | SEV2 - Minor | Wet sand+polish | 1 x \$138 |

| Left rear aluminium rim/alloy wheel | SEV2 - Minor | Rim refinish | 1 x \$130 |
| Rear right aluminium rim/alloy wheel | SEV2 - Minor | Rim refinish | 1 x \$130 |
| Rear right rocker/sill/side skirt | SEV2 - Minor | Wet sand+polish | 1 x \$115 |
| Right mirror cover/cap/shell | SEV2 - Minor | Touch-up | 1 x \$115 |
| Seat (front) | SEV1 - Cosmetic | Detailing | 1 x \$53 |
| Seat (front) | SEV2 - Minor | Spot repair | 1 x \$230 |
